WELDING INSPECTION REPORT

Resident Engineer: Siegenthaler, Peter **Report No:** WIR-019162 Address: 333 Burma Road **Date Inspected:** 07-Jan-2011

OSM Arrival Time: 900 **Project Name:** SAS Superstructure **OSM Departure Time:** 1730 Prime Contractor: American Bridge/Fluor Enterprises, a JV Contractor: American Bridge/Fluor Enterprises, a JV **Location:** Jobsite

34-0006 **Bridge No: Component: SAS OBG**

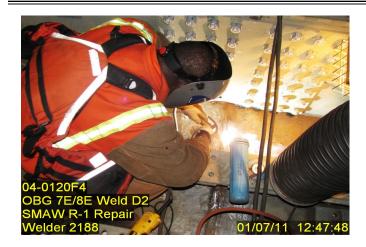
The QAI periodically observed AB/F approved welder Salvador Sandoval (ID 2202) performing fit-up, and tack welding at E4 weld 2 per the Shielded Metal Arc Welding (SMAW) process in the 1G (flat) position. See photo below. QC Inspector Steve McConnell was present to verify the fit-up, monitor the progress and verify that the welding parameters were within the limits established by the approved welding Procedure Specification (WPS) identified as ABF-WPS-D1.5-1070. The QAI also verified the fit-up at this location. The QAI observed that the

The QAI periodically observed AB/F approved welder Fred Kaddu (ID 2188) performing repair welding of four excavated areas per the Shielded Metal Arc Welding (SMAW) process in the 1G (flat) position on the interior of OBG Field Splice 8E/9E Weld D1 & D2. See photo below. QC Inspector Fred Von Hoff was present periodically to monitor the progress and verify that the repair welding parameters were within the limits established by the approved welding Procedure Specification (WPS) identified as ABF-WPS-D1.5-1000 Repair. The QAI observed that fill and cover pass welding of the four excavations was completed during the QA Inspectors shift and the work at this location appeared to be in general compliance with contract documents. The QAI observed that the repair areas excavated on this date on the interior of weld D1 had the following dimensions and the following Y locations:
